INSTALLATION INSTRUCTIONS

Accessory
CD PLAYER

Application
2016 PILOT

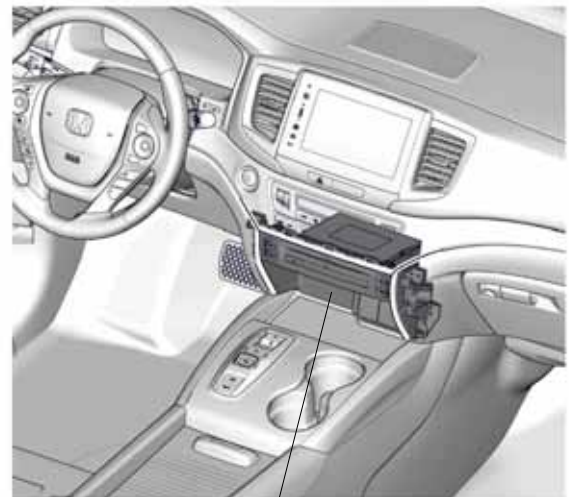
QDN2701AG

Illustration of the CD Player Unit on the Vehicle

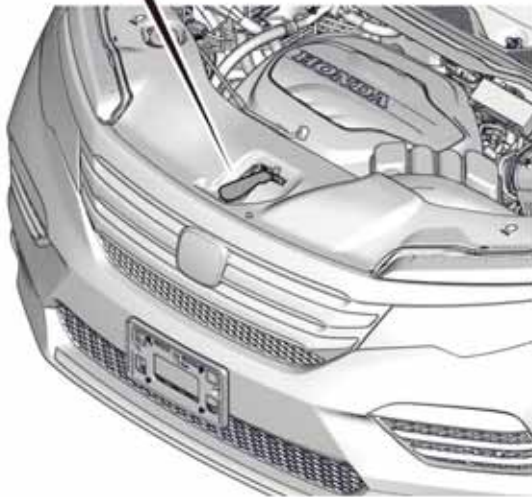
QDN1301AA

1. Wrap a shop towel around the hood latch.

HOOD LATCH
(Wrap with a shop towel.)

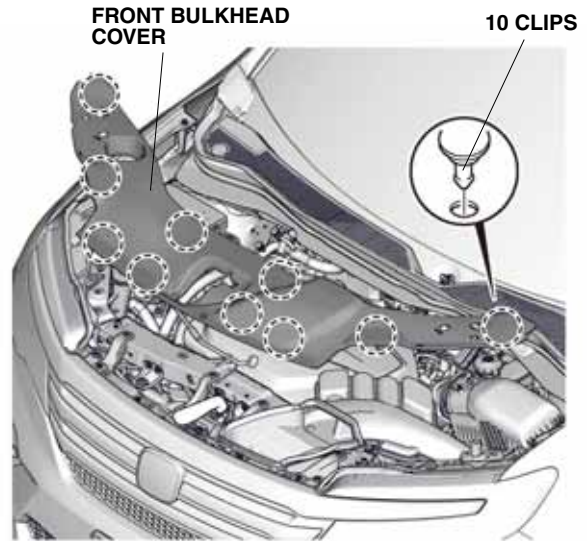
QDN1302AA

- Remove the front bulkhead cover.

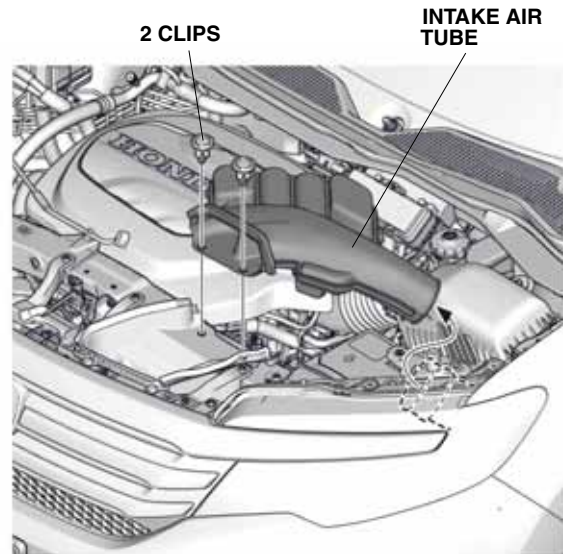
QDN1303AA

- Remove the intake air tube.
- Disconnect the negative cable from the battery.

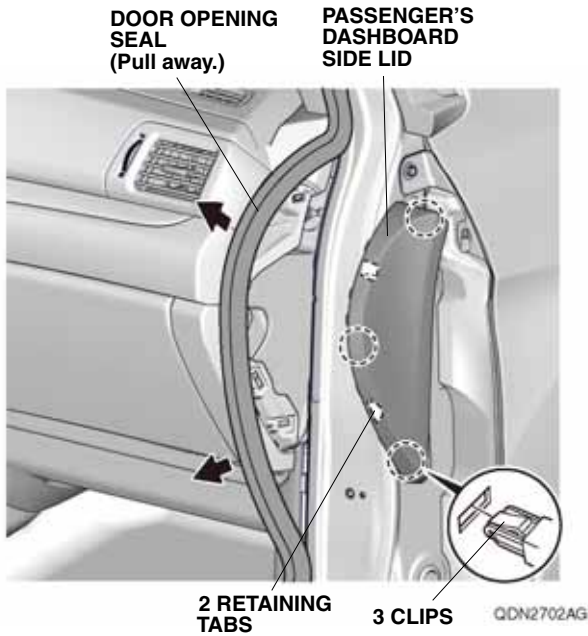
2. Pull away the door opening seal, and remove the passenger's dashboard side lid.

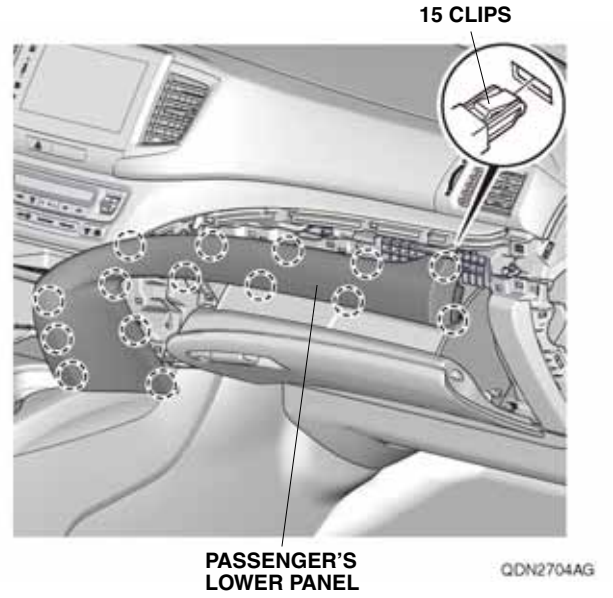
4. Remove the passenger's lower panel.

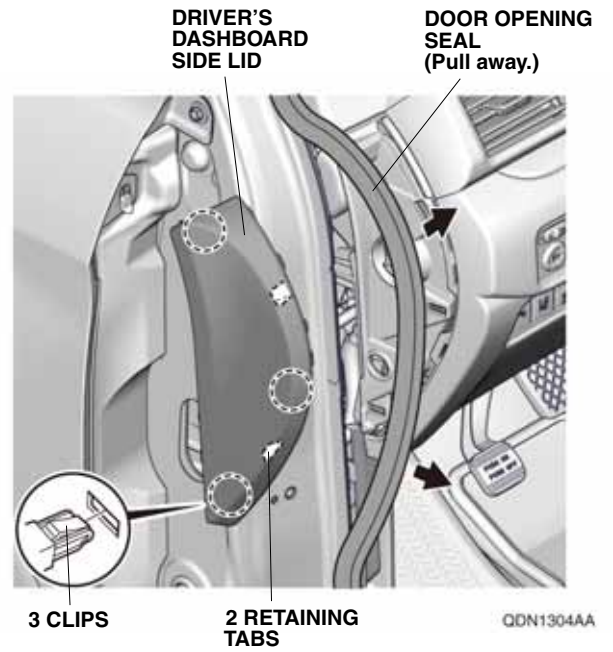
5. Pull away the door opening seal, and remove the driver's dashboard side lid.

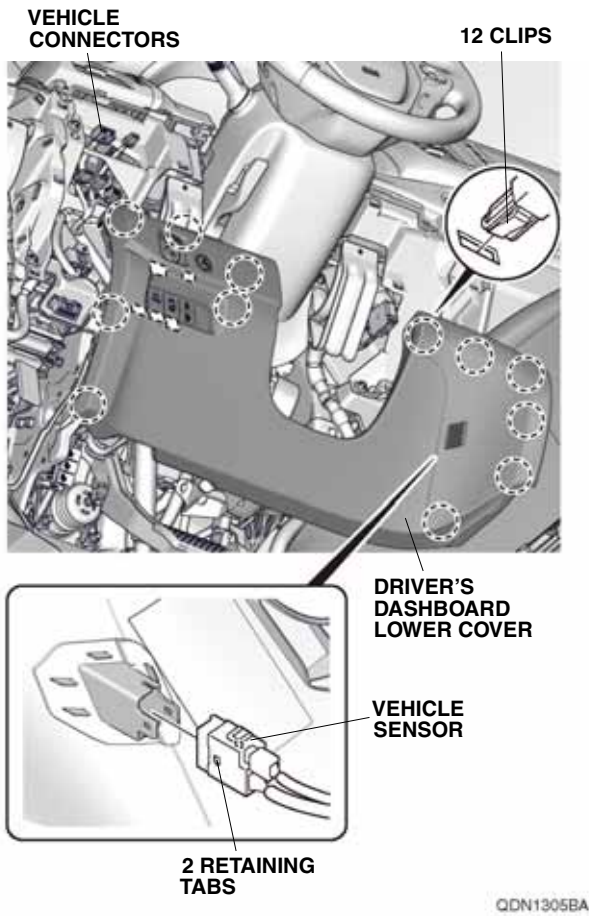
- Remove the driver's dashboard lower cover and release the vehicle sensor.

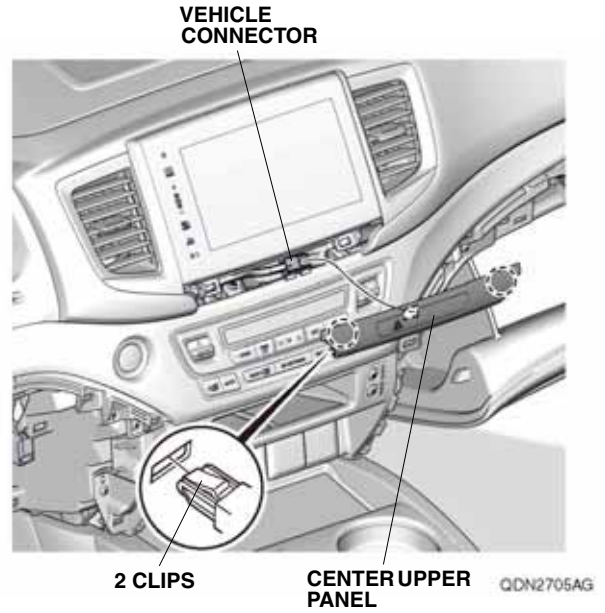
- Remove the center upper panel and unplug the vehicle connector.

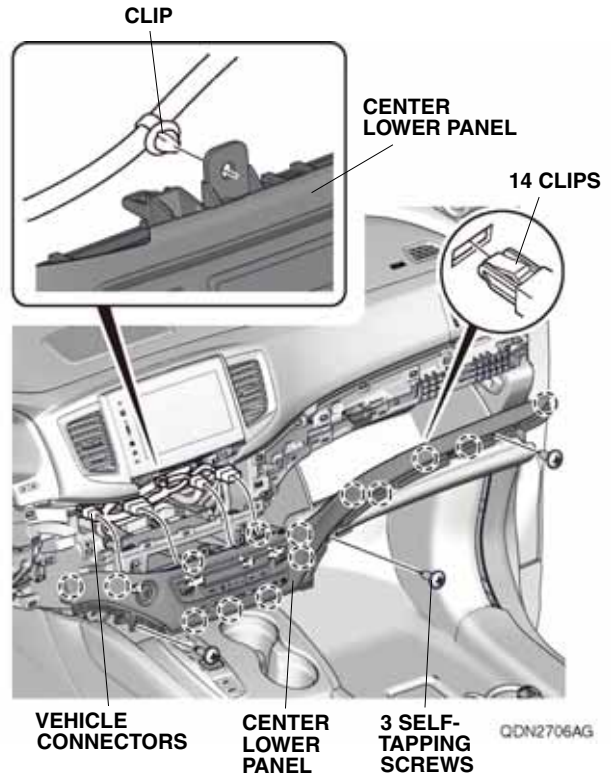
- Remove the center lower panel and unplug the vehicle connectors.

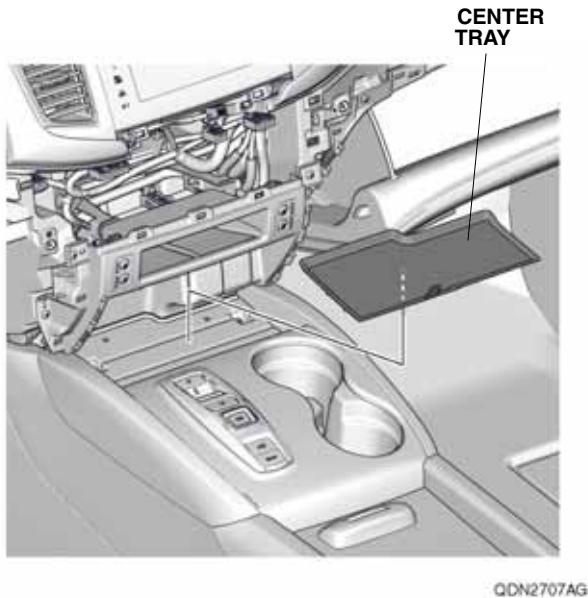
- Remove the center tray.

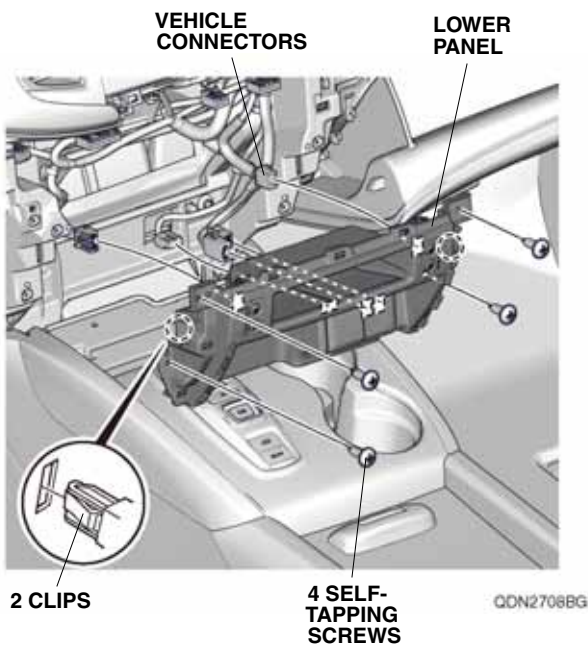
- Remove the lower panel and unplug the vehicle connectors.

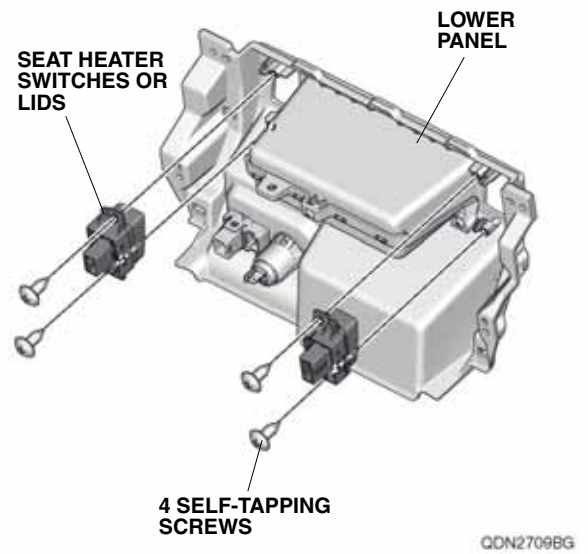
- Remove the seat heater switches or lids from the lower panel.

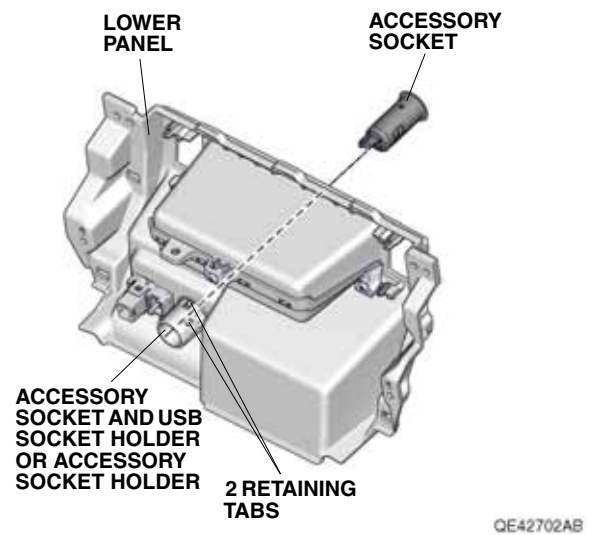
- Remove the accessory socket from the accessory socket and USB socket holder or accessory socket holder.

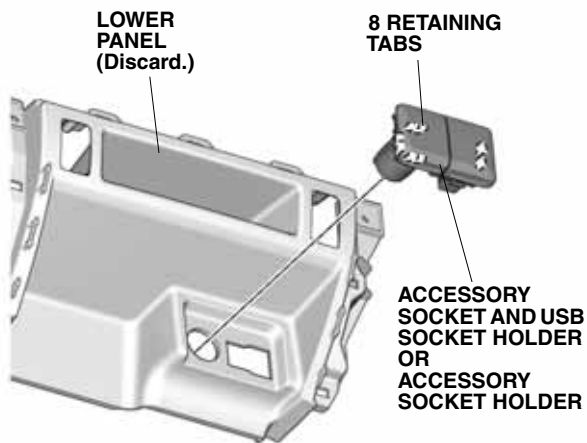
QDN2710BG

- Remove the accessory socket and USB socket holder or accessory socket holder from the lower panel. If vehicle is equipped with the accessory socket holder, discard it.

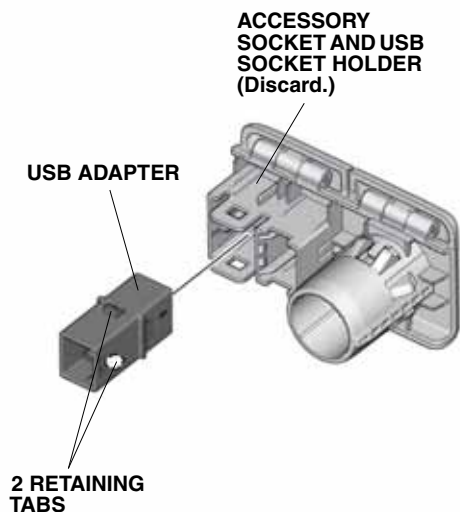
QE42703AB

- Remove the USB adapter from the accessory socket and USB socket holder removed in step 13.

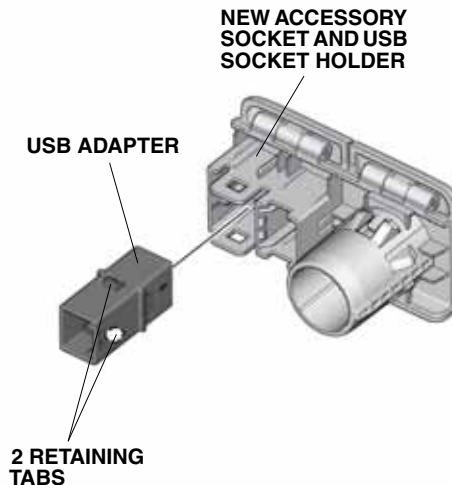
QE42703AB

- Install the USB adapter removed in step 14 onto the new accessory socket and USB socket holder.

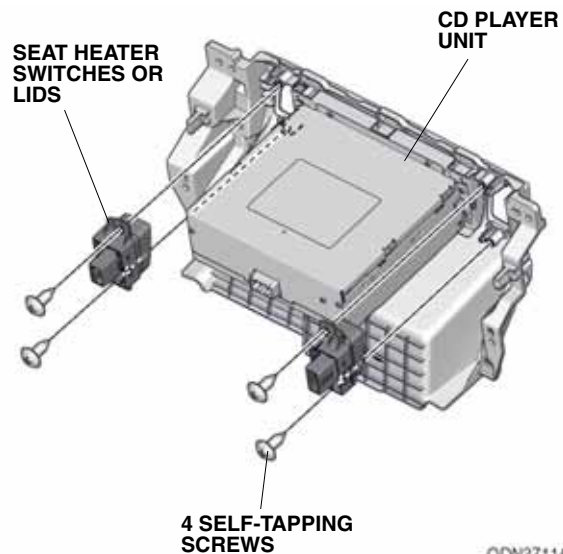
QDN2711AG

- Install the seat heater switches or lids to the CD player unit with four self-tapping screws removed in step 11.

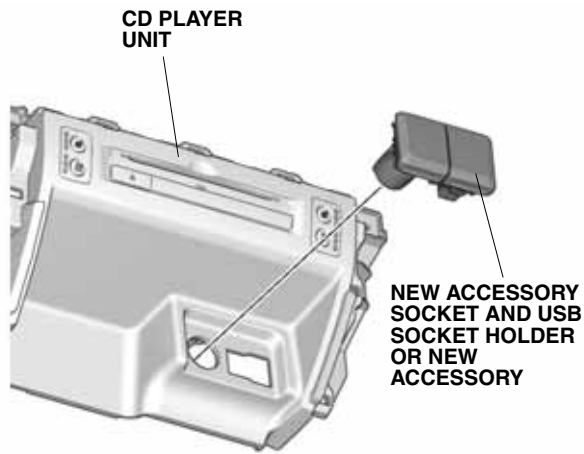
QDN2712BG

17. Install the new accessory socket and USB socket holder or new accessory socket holder on the CD player unit.

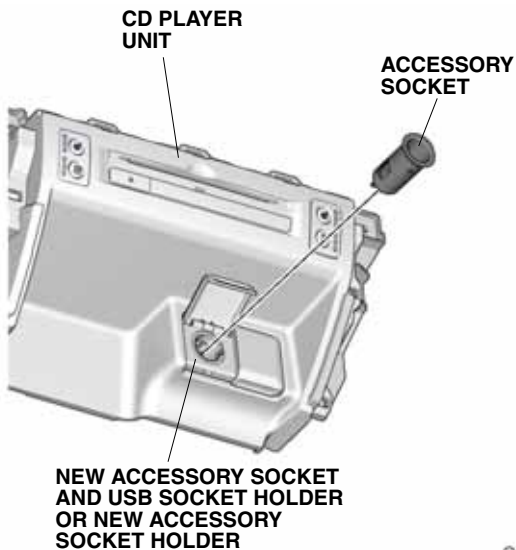
QE42704AB

18. Install the accessory socket removed in step 12 to the new accessory socket and USB socket holder or new accessory socket holder.

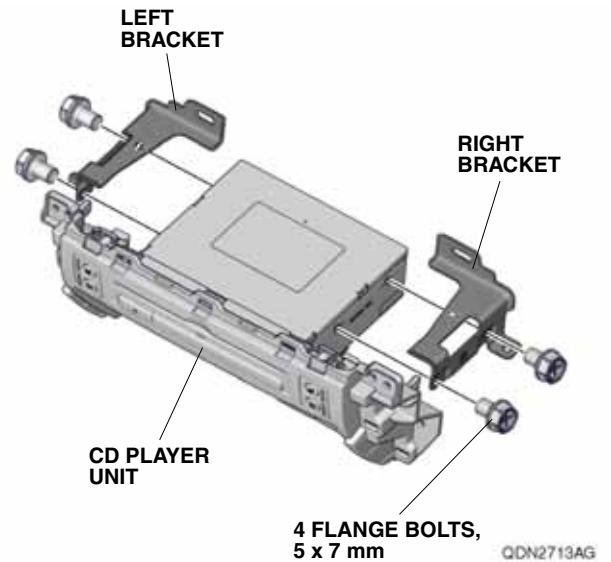
19. Install the left and right brackets on the CD player unit with four 5 x 7 mm flange bolts.

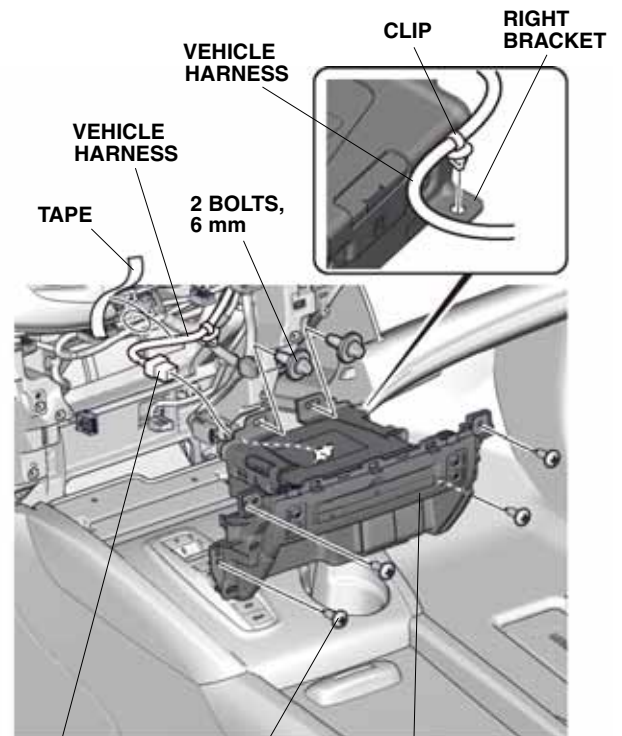
20. Remove the tape from the vehicle harness.

VEHICLE CONNECTOR 4 SELF-TAPPING SCREWS CD PLAYER UNIT QDN2714AG

21. Plug the vehicle connector, and secure the vehicle harness to the right bracket with clip on the vehicle harness.
22. Install the CD player unit to the dashboard with two 6 mm bolts and four self-tapping screws removed in step 10.
